Breezy Point City Hall Facility Assessment

City of Breezy Point
8319 Co Rd 11
Breezy Point, MN 56472

Widseth Project No. 2022-12001

Final Report
04.19.23

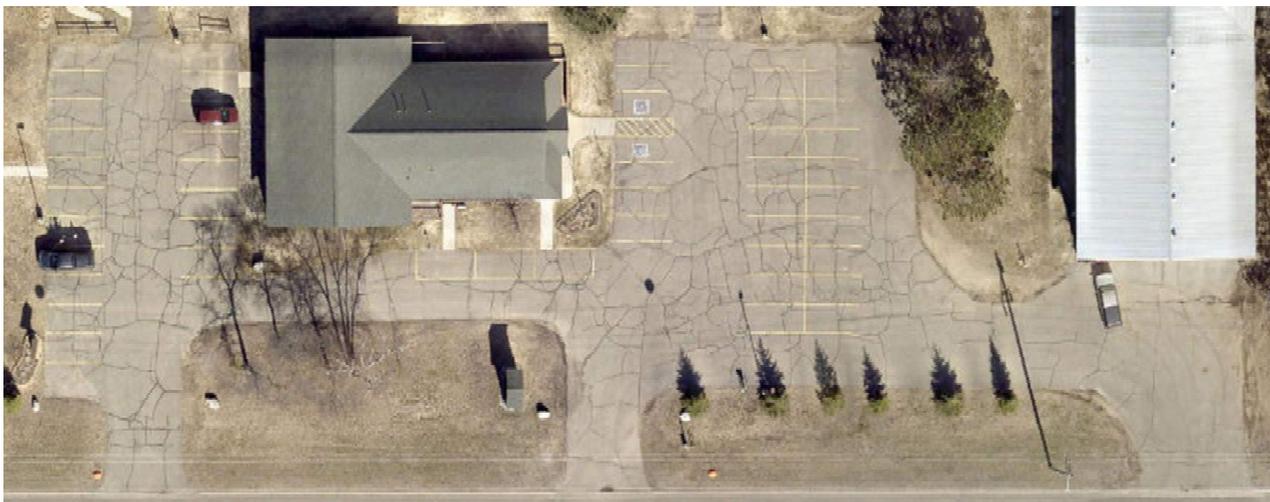
1. Parking Area and Stormwater Management

The parking lot is the original pavement and is approximately 28 years old and is in poor condition. Considerable fatigue cracking has occurred, and the pavement has begun to fall apart. The life expectancy of bituminous pavement is about 20-30 years. Ponding water on pavement can decrease its life expectancy. Lighting appears to be inadequate in the parking area. Lighting improvements would enhance the parking areas safety and accessibility.

Photo: Aerial photo depicting the current condition of the parking area.

- It is recommended that the pavement be reclaimed and repaved in the next 5 years. It is also recommended that measures be taken to enhance stormwater management on the site. The recommended options include grading improvements and infiltration basins or stormwater system installation. A stormwater analysis would be required to determine the feasibility of either option. It is recommended that additional lighting units be added to the parking area.

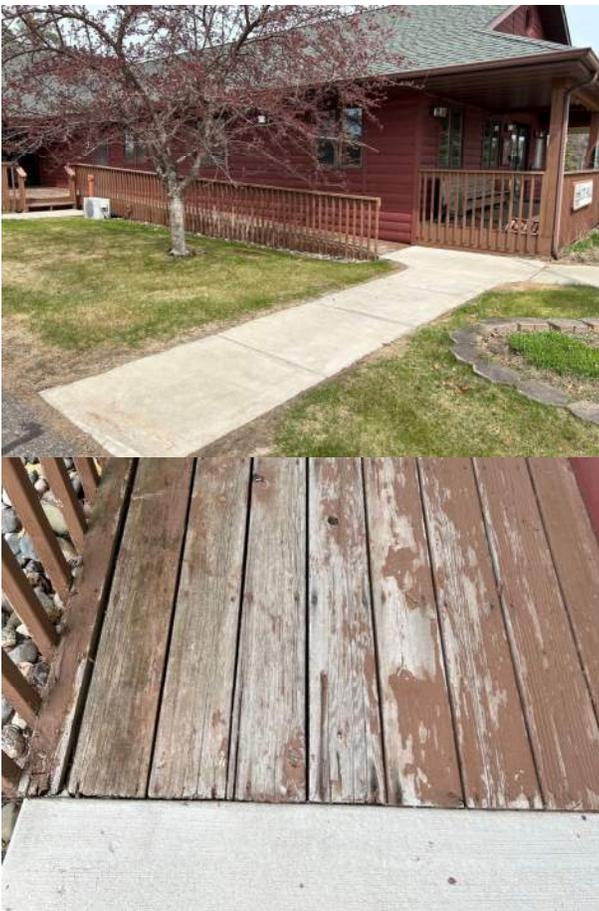
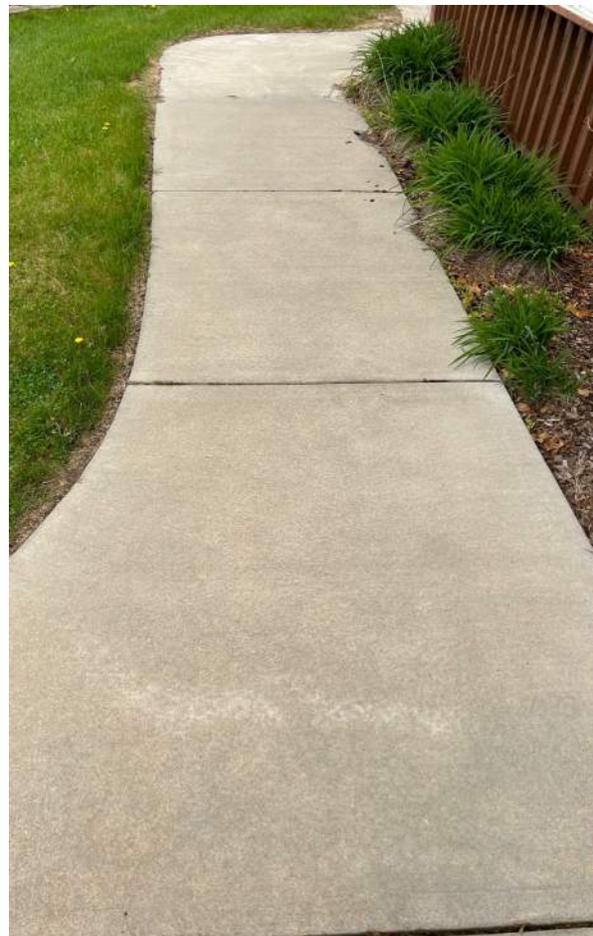
2. Sidewalks and ADA Compliance

The sidewalk pavement is original pavement and appears to be in fair condition. Concrete pavement life expectancy is about 20-30 years. The wooden access ramps are in fair condition and concern has been expressed about their longevity.

Photos: Existing conditions of sidewalks and ADA access ramps.

- It is recommended that the access ramps material be evaluated for a more maintenance free and ADA compliant alternative and replaced within the next 5 years. It is also recommended that the sidewalk be replaced in the next 10 years.

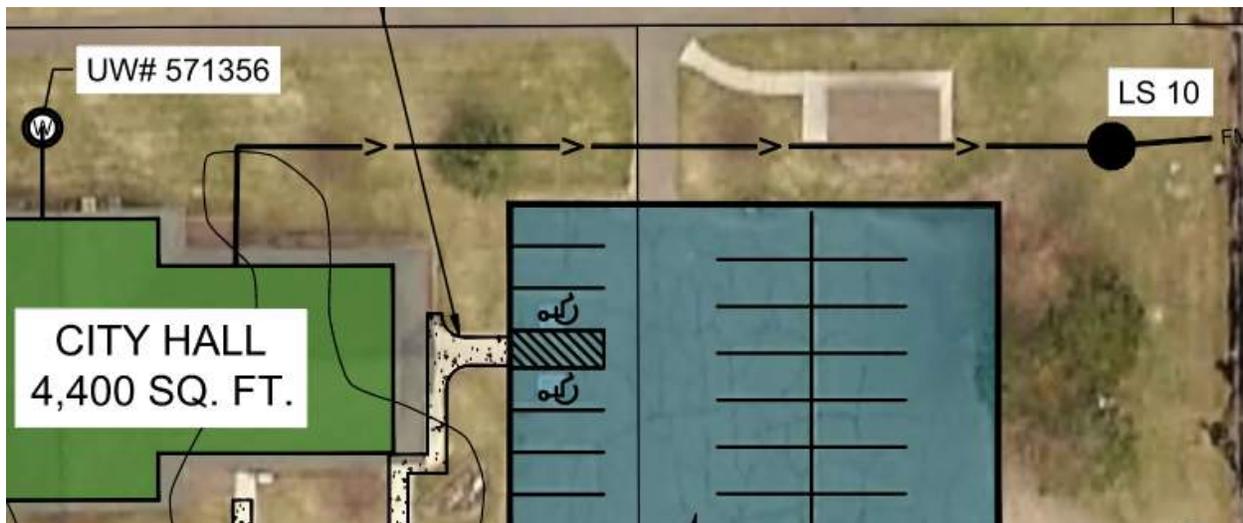
3. Sanitary Sewer

The sanitary sewer consists of 6" PVC gravity service pipe leading to a lift station (LS-10). The lift station then pumps to the City sanitary sewer system. The lift station is assumed to be 28 years old . The life expectancy for the lift station pump is approximately 10 years.

Photos: Approximate sanitary sewer service line and lift station location.

- It is recommended that a cleanout be installed at the bend of the sanitary service in the next 5 years. The City should also anticipate that the lift station pump will require replacement within 5 years.

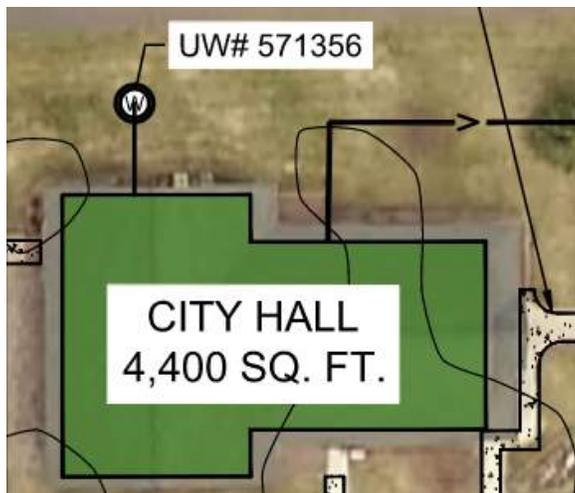
4. Water Service/Well

The well servicing the City Hall is approximately 28 years old. There is a second well servicing the storage building that's age is unknown. The life expectancy for a well pump is largely dependent on external factors.

Photos: Approximate well location.

- It is recommended that the pumps for both wells be replaced simultaneously in the next 15 years. The City should consider the need for the well servicing the storage building and analyze both wells for compliancy with the Minnesota Department of Health.

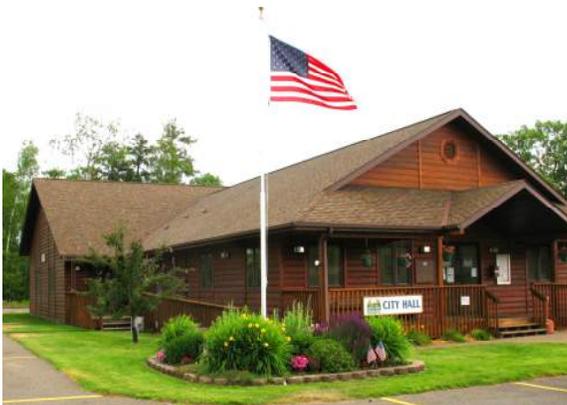
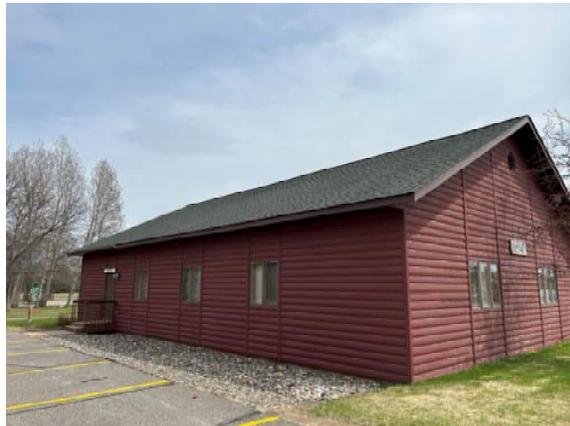
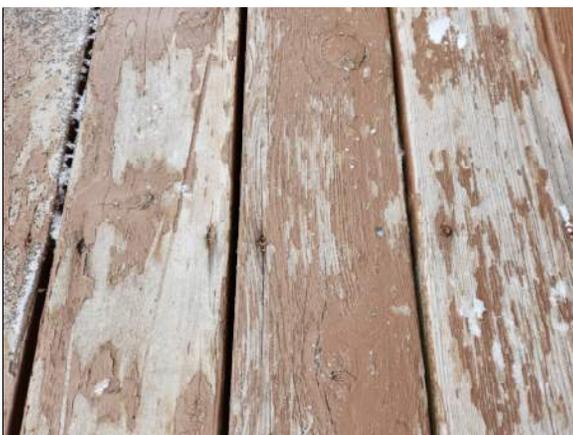
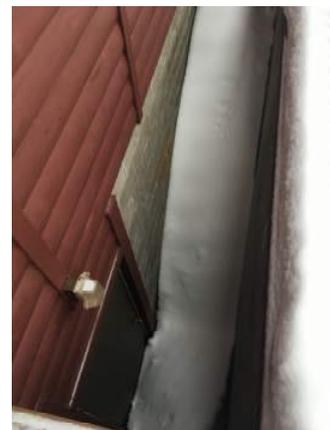
1. Exterior

The Exterior is made up of wood siding and vented soffit. The overall exterior appears to be in fair condition. The wood decking for the ramps are showing heavy wear and should be replaced in the next 5 years. The stair exit from the basement should be protected to keep it from infilling with snow.

- Repair and replace ramp boards as needed
- Construct a roof over the basement stairs

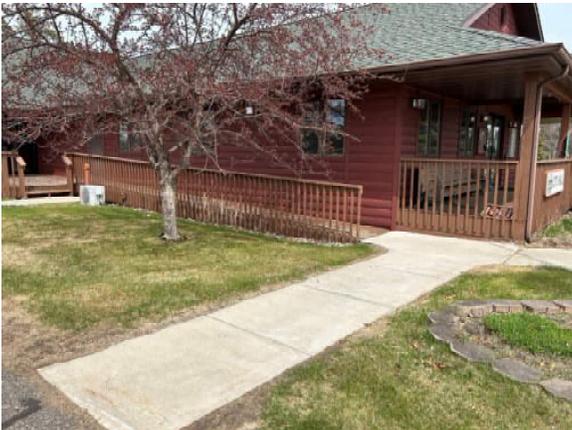
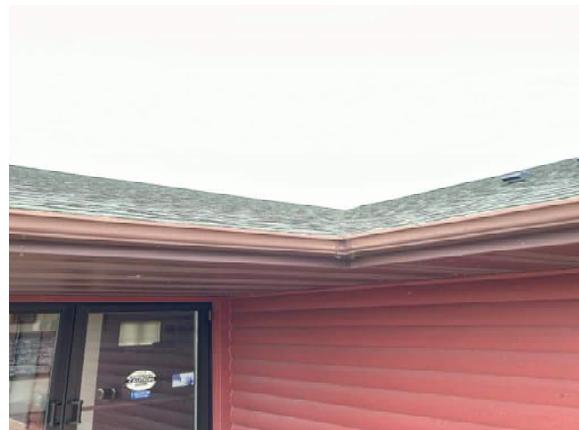
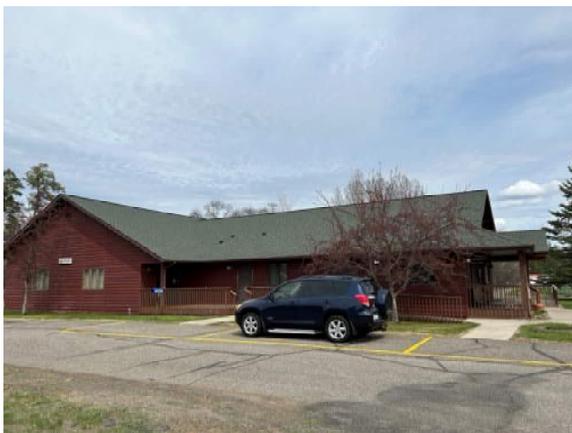
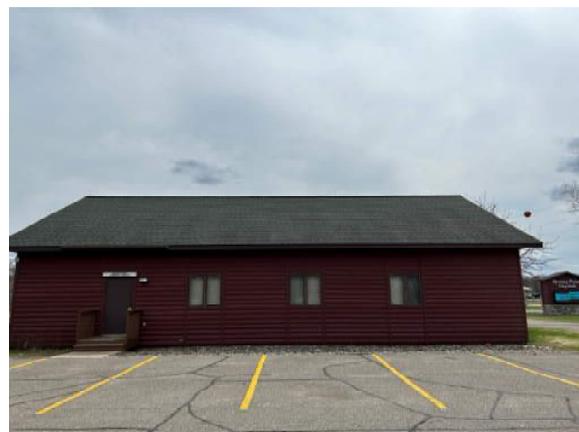
2. Roof

The existing roof is an asphalt shingle roof and is less than 10 years old. The existing roof drainage system is comprised largely of uncontrolled roof runoff except for several rain gutters over walking paths.

- The shingled roof should be replaced within the next 10 years. Gutters should be installed with extensions to direct the water away from the foundation.

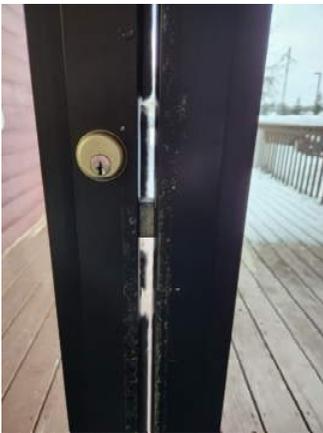
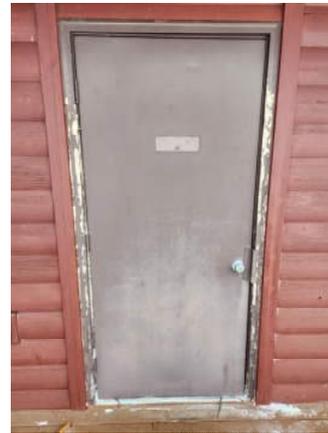
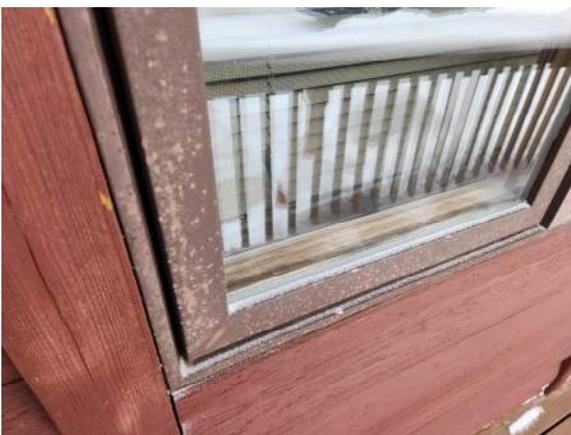
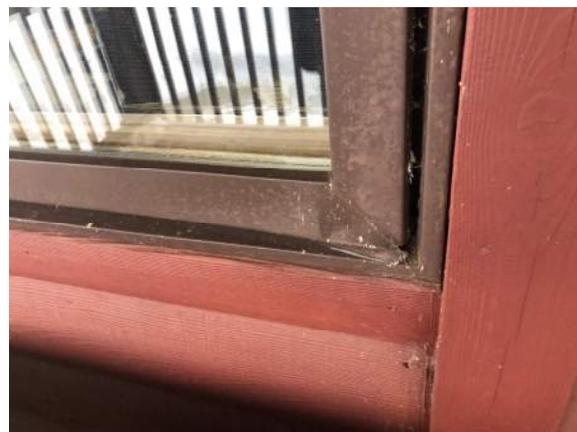
3. Exterior Doors, Windows and Caulking

The aluminum doors and frames are showing wear and are not providing an effective weather barrier. Exterior metal doors are showing heavy wear and the seals are deteriorating. The windows are in fair condition but show signs of condensation. There are several areas that need caulking/re-caulking.

- Exterior doors and windows should be replaced with a high-performance thermal energy efficient system. Remove and/or install new caulking around all building penetrations to prevent water and air infiltration.

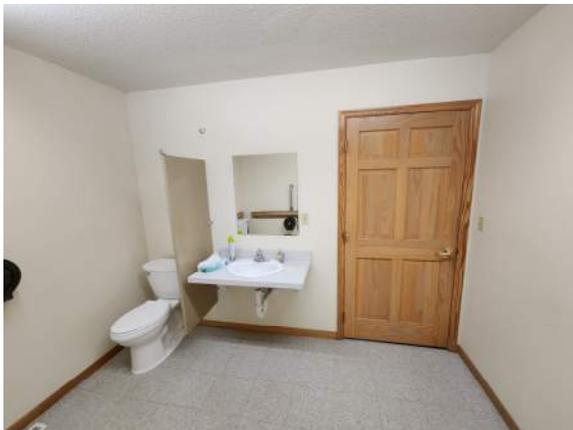
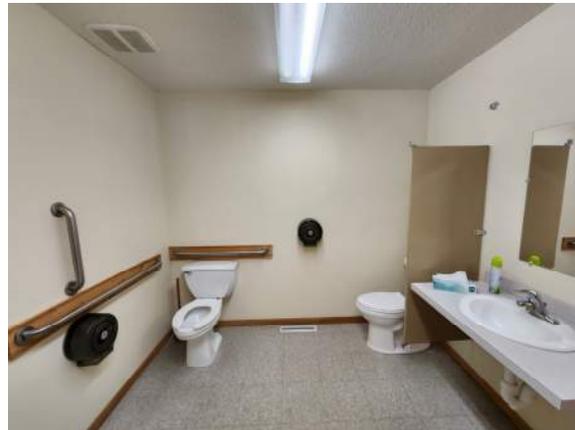
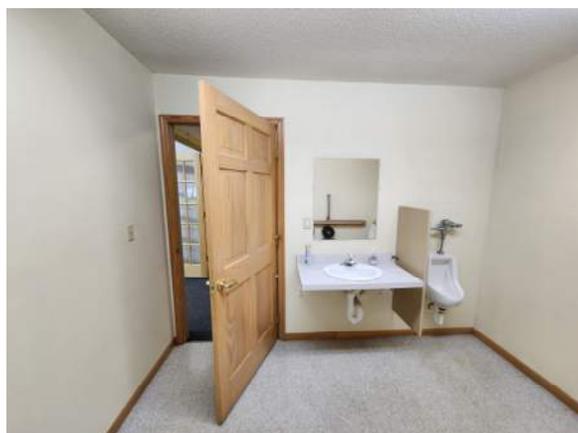
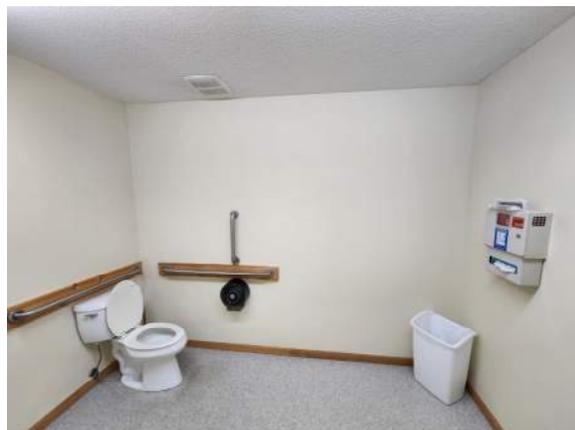
4. Restroom Accessibility

The existing restrooms are located on the main floor and are not accessible. The pull side of the doors do not allow 18 " of clearance.

Photos: (Women's restroom above and men's restroom below)

- This restrooms will need to be reconfigured to provide the adequate clearance on the pull side of the doors as defined by the 2020 Minnesota Accessibility Code. This reconfiguration would require a remodel and would impact the overall layout of the interior space of the building, including the relocation of the plumbing fixtures.

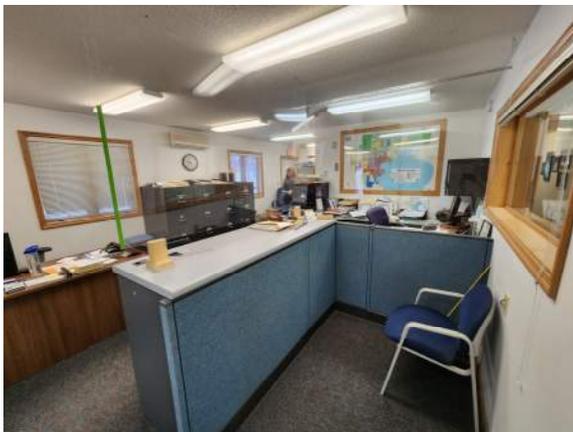
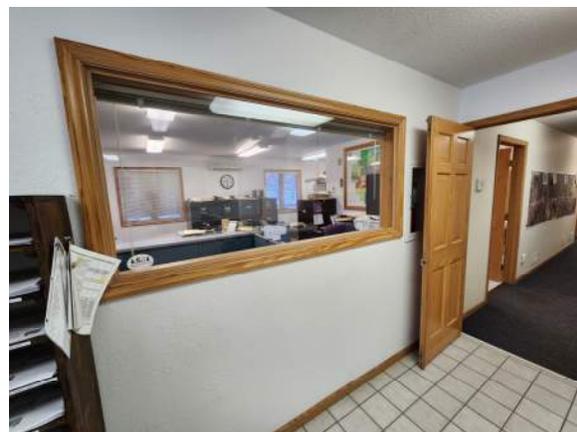
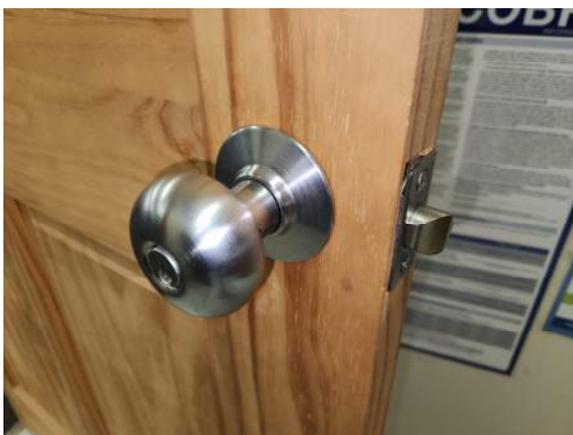
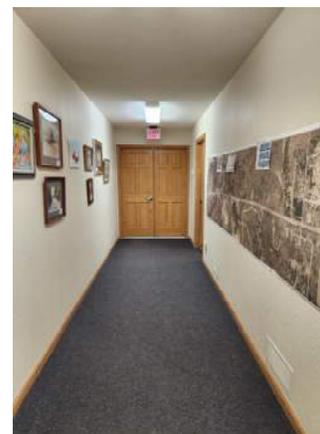
5. General Accessibility

The reception desk does not have an ADA accessible counter. Many of the doors do not provide ADA approved hardware. The kitchen does not allow accessibility to counters or the sink. When the council chambers serve as the community room and the doors are locked to the offices a dead-end corridor condition is present. There is non tempered glass present within 3' of a door.

- The reconfiguration of the corridor would require a remodel and would impact the overall layout of the interior space of the building. Cost would be dependent on future design.
- Replace existing hardware with ADA compliant. Remodel to incorporate ADA accessible counter and kitchen area.

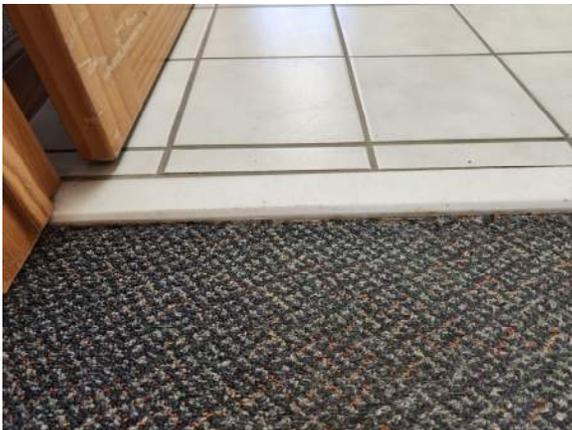
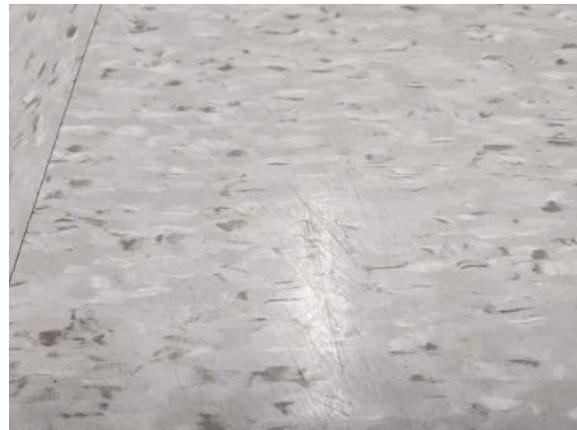
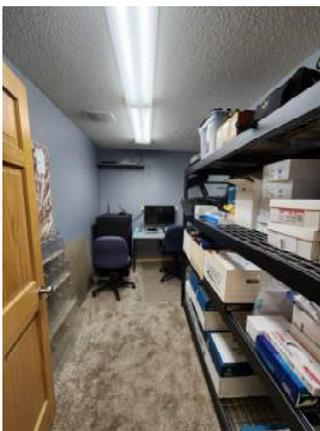
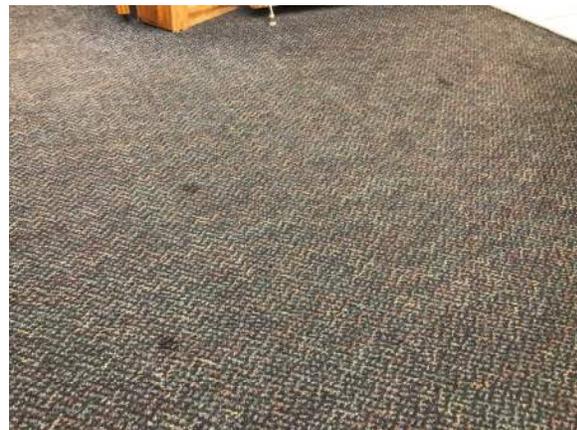
6. Interior Floor Finishes

The existing floor finishes consist of ceramic tile, carpet, VCT, and concrete in the basement. Ceramic tile and VCT are in fair condition with some areas of high abrasion. The carpet is showing wear and should have proper transitions to adjacent materials. The server room carpet should be replaced with an anti-static material.

- Replace carpet in high traffic areas with durable carpet tile, as well as commercial cleaning of carpet in office areas. Replace transitions where necessary. Replace carpet in server room with anti static carpet.

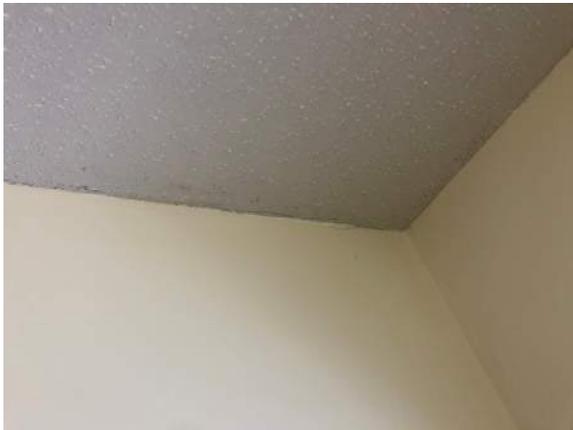
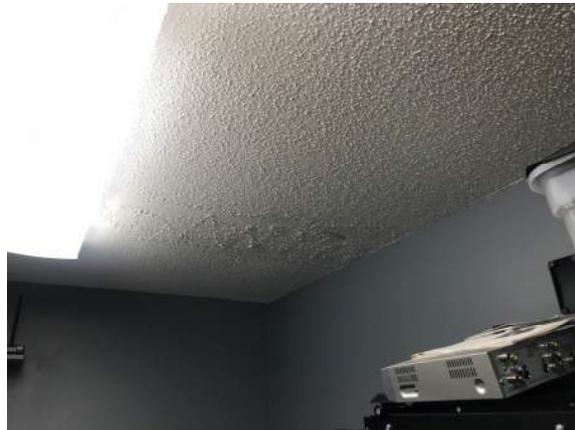
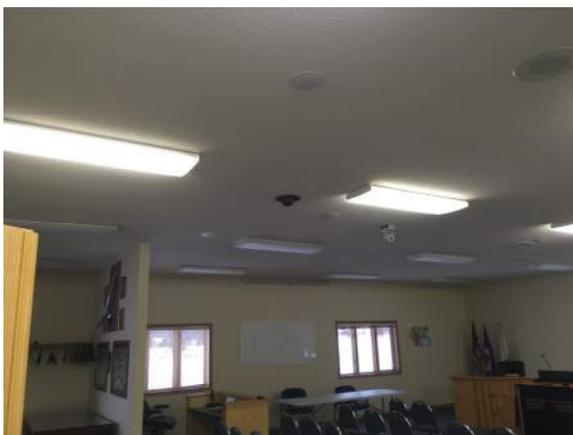
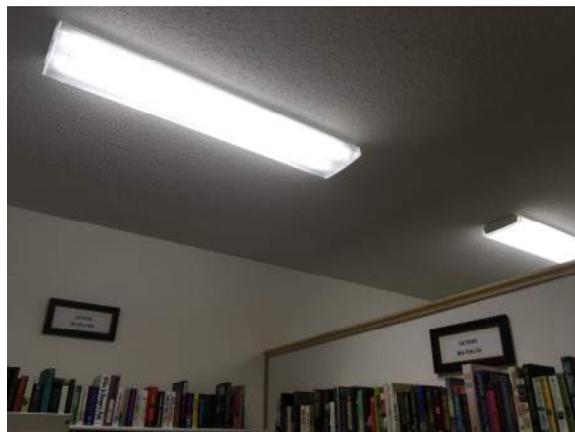
7. Interior Ceiling Finishes

The existing ceiling consists of gypsum board with a popcorn finish. There are several areas that are need repair and repainting.

- Repair and repaint damaged areas of ceiling ad needed.

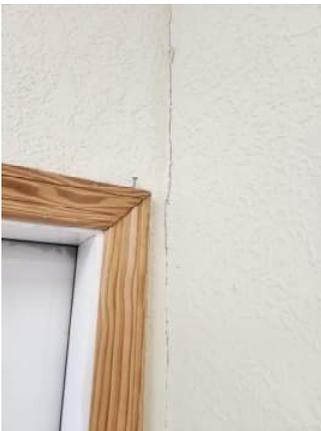
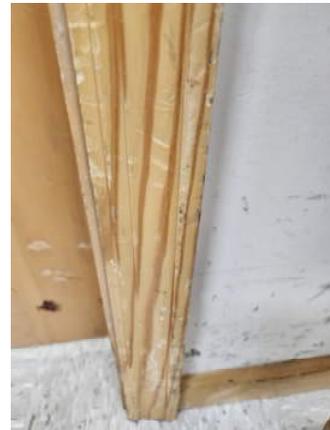
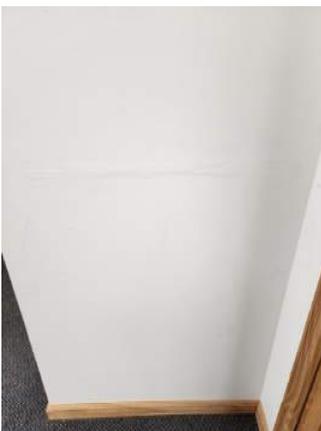
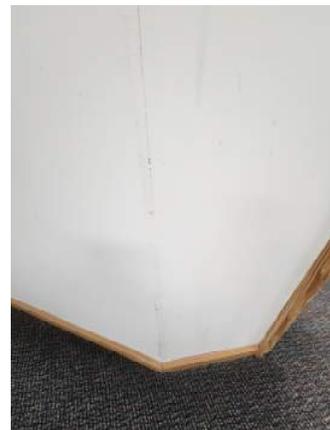
8. Interior Gypsum Board Wall Repair and Repainting

Throughout the building, there are walls and ceilings that have damaged gypsum board that need to be repaired and repainted.

- Repair walls and repaint these damaged areas from corner to corner, or along an entire surface to ensure that there is a consistent finished wall or ceiling surface with the same paint sheen.

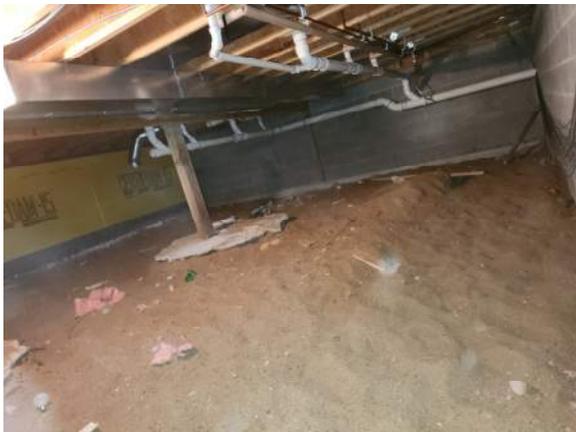
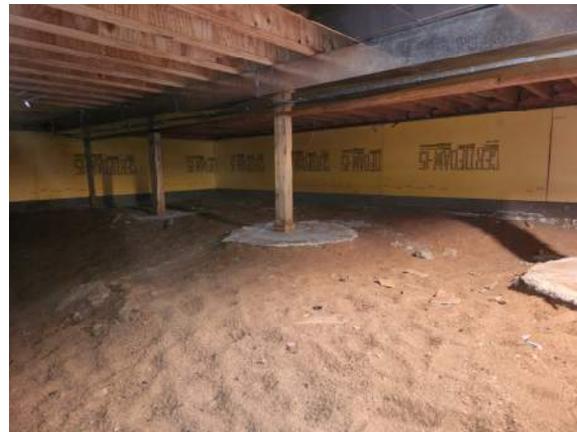
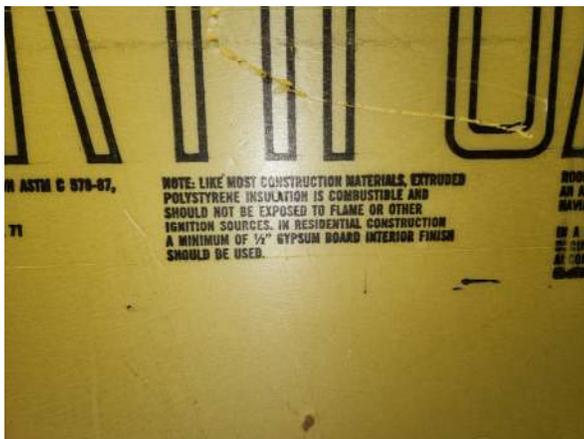
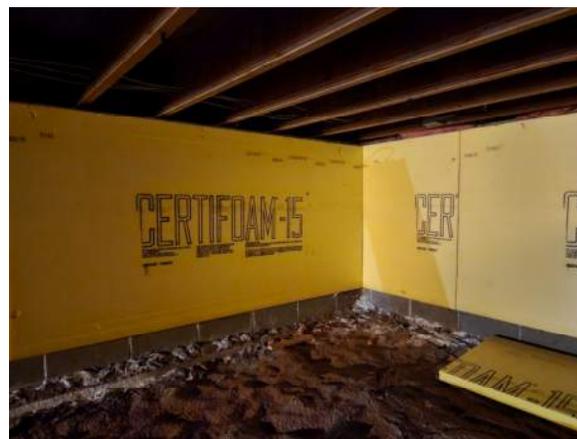
9. Unconditioned Crawl Spaces

The crawl spaces are currently not ventilated to the exterior and there is not a soil-gas-retarder to prevent the infiltration of moisture from the ground below. The existing rigid insulation along the interior side of the foundation wall is exposed to the interior.

- Encapsulate the crawl space with a minimum of 6 mil poly vapor barrier along the floor of the crawl space, install gypsum board to the face of the rigid insulation and install vents to the exterior to provide ventilation.

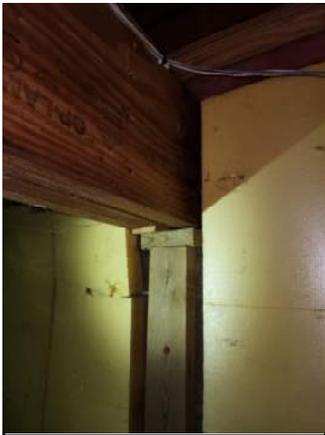
1. Structural Column

The existing structural support columns in the crawlspace are not allowed to be shimmed.

Photos: (Photo shows shim on top of support column)

- Replace shims with appropriate materials at column locations

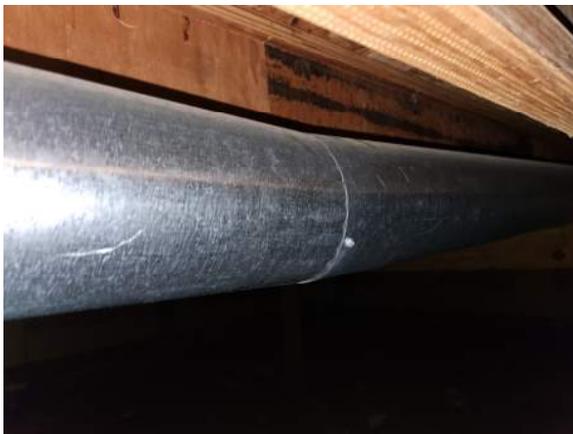
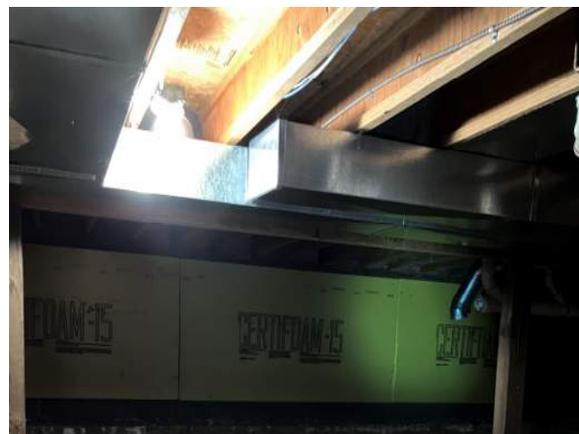
1. Uninsulated Ductwork

Staff indicated the building is cold in the winter and warm in the summer. It was observed that the ductwork in the crawlspaces is not sealed or insulated. 2020 Minnesota Energy Code requires a minimum of R-3.3 insulation for ductwork in a similar space.

- Seal duct connections and insulate ductwork in crawlspaces.

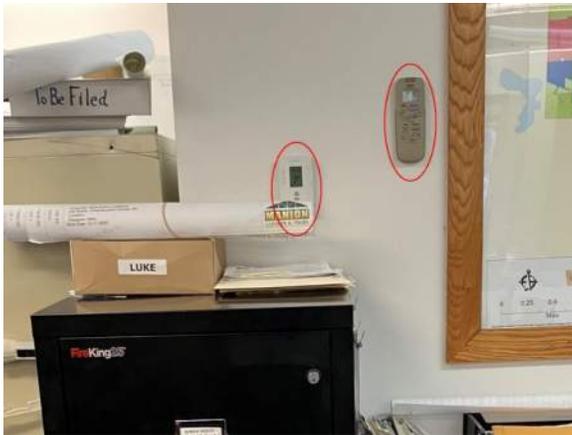
2. Thermostat Location

The thermostats for the west side office and the mini-split a/c unit are adjacent to each other. See photo. In the summer, the mini-split a/c unit could be satisfying the thermostat for the furnace, causing the furnace to not supply cooling to the west side offices. This could be a contributing factor to the temperature issues described by the staff.

- Relocate furnace zone thermostat to southwest office.

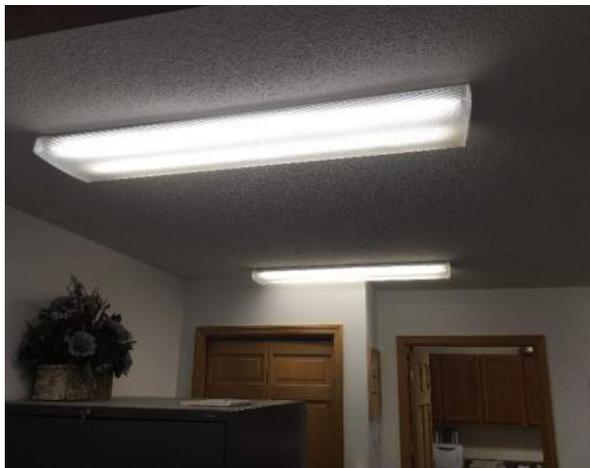
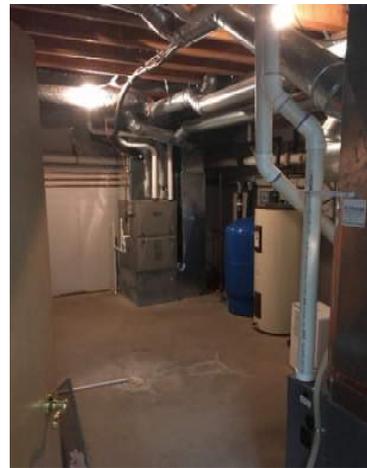
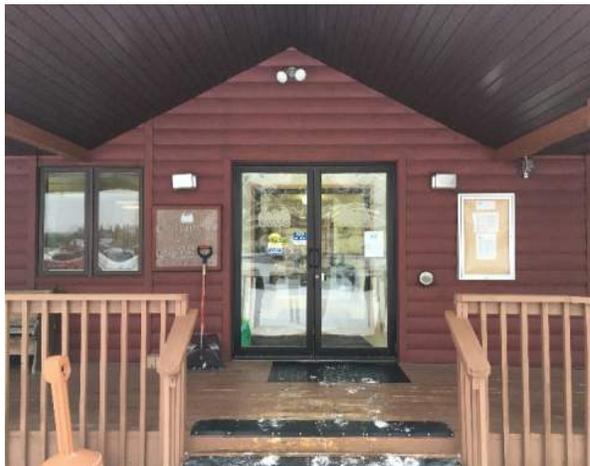
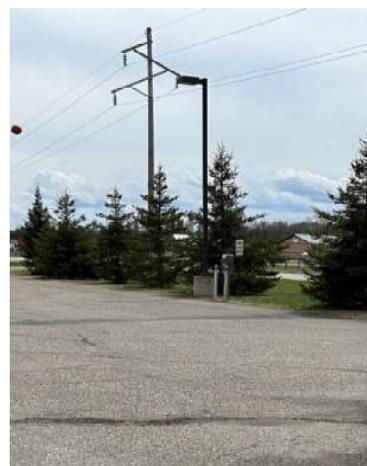
1. Lighting

The lighting in the building is primarily fluorescent type lighting fixtures, with some incandescent type fixtures in the basement. The exterior building mounted fixtures and parking lot lights are metal-halide fixtures. All existing fixtures appear to be functional. LED type lighting fixtures typically consume much lower amounts of electricity. To reduce electrical power usage and save on electrical energy costs, all non-LED light fixtures should be replaced with LED type light fixtures.

- Replace the non-LED lighting fixtures with LED type lighting fixtures.
