Breezy Point City Hall Facility Assessment

City of Breezy Point
8319 Co Rd 11
Breezy Point, MN 56472

Widseth Project No. 2022-12001

Final Report
04.19.23

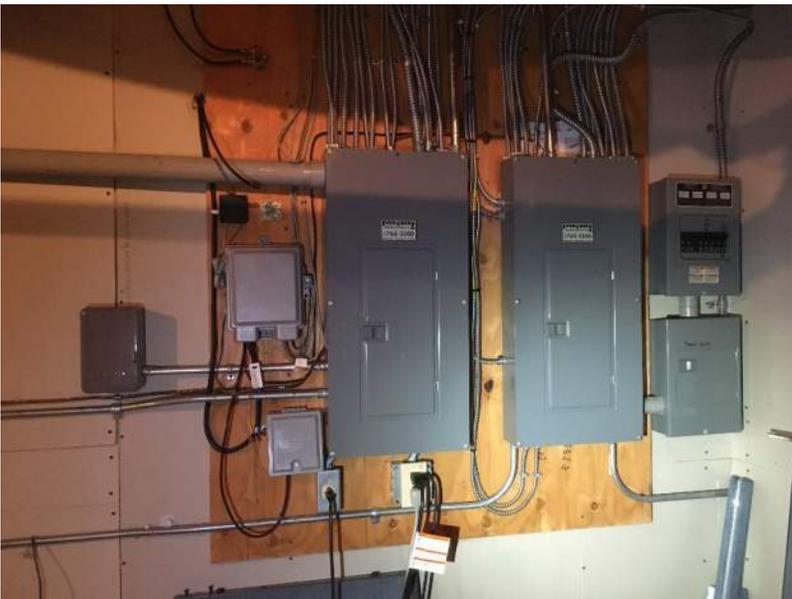
The City Hall building is in good electrical condition, overall, and is serviced with a 120/240V, single phase electric service to two 150A panels and one 100A load center. There are 12 available spaces for additional circuits. There is a 60A portable generator connection labeled as a “transfer switch”. All major electrical systems were installed in approximately 1995.

NOTE: In the event that the city elects to move forward with an addition to the existing building, it would most likely be required to upgrade the electrical service rating, which would include removing and replacing the service conductors from the utility transformer to the building and removing and replacing the existing electrical panels with new electrical panel(s) with a higher ampacity rating.
